IN THE UNITED STATES DISTRICT COURT FOR THE DISTRICT OF MARYLAND

In the Matter of the Petition of	
GRACE OCEAN PRIVATE LIMITED, as Owner of the M/V DALI,	Civil Action No. 1:24-cv-00941
and)	IN ADMIRALTY
SYNERGY MARINE PTE LTD, as Manager of the M/V DALI,	
for Exoneration from or Limitation of Liability.)

UNITED STATES' CLAIM AND ANSWER TO PETITIONERS GRACE OCEAN PRIVATE LIMITED AND SYNERGY MARINE PTE LTD'S PETITION FOR EXONERATION FROM OR LIMITATION OF LIABILITY

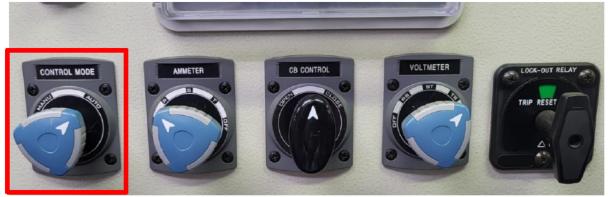
- 67. There are two control modes for the number 1 and number 2 step-down transformers: "automatic" and "manual."
- 68. When in the automatic mode, if there is a loss of power through one of the step-down transformers, then the electrical system automatically transfers power to the other step-down transformer. Automatic transfer does not require crew intervention and results in the restoration of electrical power to the ship in a small number of seconds.

- 69. In contrast, when in manual mode, if there is a loss of power through one of the step-down transformers, the DALI's crew must manually transfer electrical power to the other step-down transformer—while in the darkness of a power outage.

Step-down transformer controls, with the Auto/Manual Control Mode selector at far left.

This photograph was taken post-accident.

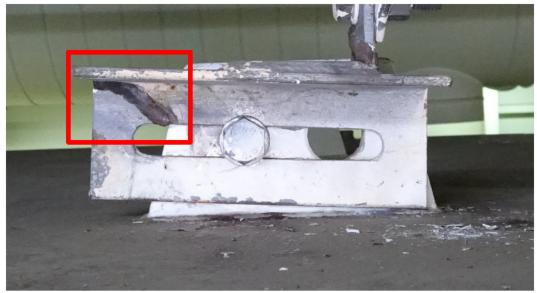
- 73. Excessive vibrations caused multiple cracks to form in one of the braces to the number 1 step-down transformer, including in the steel bracket between it and the top of the transformer.

Cracked steel bracket with weld repair at the number 1 step-down transformer.

- 76. Problems obviously persisted after the rod's installation, since the steel bracket atop the number 1 step-down transformer cracked again.
- 77. The DALI's vibration issues were documented, well-known, and of concern to the crew. As explained in the introduction, the prior captain of the vessel noted "heavy vibration" in his handover notes on May 23, 2023, and he reported the same to Synergy:

- 74. Rather than address the underlying vibration problem, or even replace the cracked component, Petitioners simply welded over the cracks and carried on with business as usual.
- 75. The DALI also had a vibration dampening rod wedged between the number 1 step-down transformer and a steel beam in the transformer room. It was jury-rigged, in the literal sense, from spare cargo equipment and painted white on one end. The anti-vibration rod is an after-market modification, not original to the build of the ship.

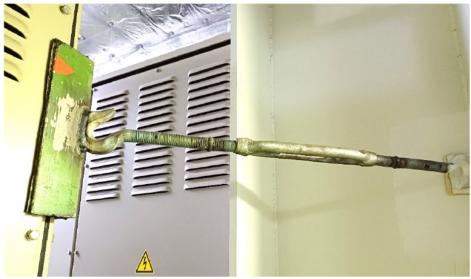
Cargo chain turnbuckle, welded to angle iron, and wedged between the number 1 step-down transformer (left) and a steel beam (right).

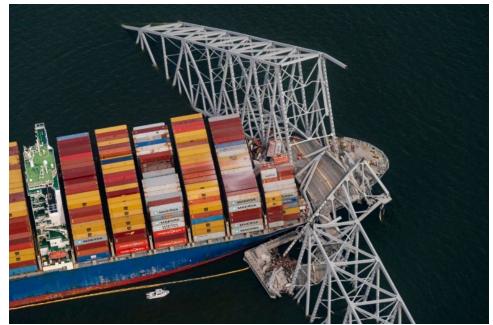
- 142. The remnants of the Francis Scott Key Bridge fell onto and were draped across the bow of the DALI, while other parts dropped into the Fort McHenry Channel and the Patapsco River.

Wreck of the DALI intertwined with the bridge in the Fort McHenry Channel.
